Fracture Analysis of a First Stage Turbine Blade by FRANC3D

Abstract. The premature failure of a blade occurred after a service life of 8127 EOH operation hours. This paper presents the fracture analysis of the first stage blade through fractographic and mechanical analysis. Crack growth mechanisms were evaluated based on the microscopic observations of the fracture surfaces by SEM. The analysis of the different region of the fracture surface shows that crack propagation is mainly related with fatigue mechanism. The crack propagation occurred in the pressure-suction side direction. The dynamic characteristics of the blade were evaluated by FEM in order to identify the cause of blade failure. The result depicts that the second mode of vibration might be excited and the vibratory stresses cause to HCF damage of the blade. Eventually fracture analysis of the blade under the presence of a fatigue crack was analyzed by FRANC3D software.

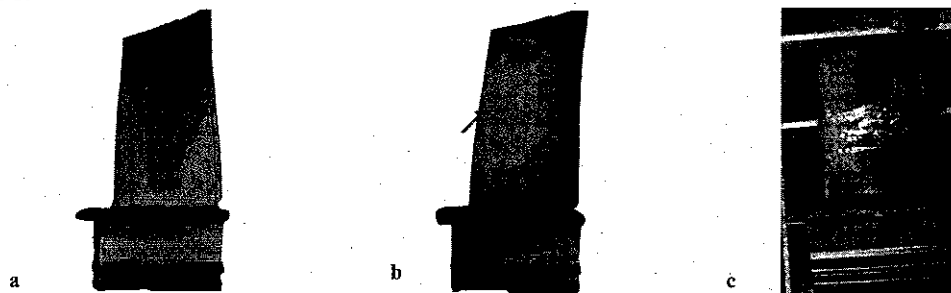
Fig. 2. Stress distribution for the blade in different vibration modes: (a) First mode-bending; (b) second mode- torsion; (c) arrows imply to initiation site of fatigue cracks in the damaged blade

In respect with the position of fatigue cracking in broken part (Fig. 2c) and comparing with stress plot of the second vibration modal shape; it can be easily recognized that the peak stress of the blade comply with where cracks initiated. Therefore; the second mode of blade vibration has probably been excited in this case of fracture. Generally; there are two possible vibration excitation

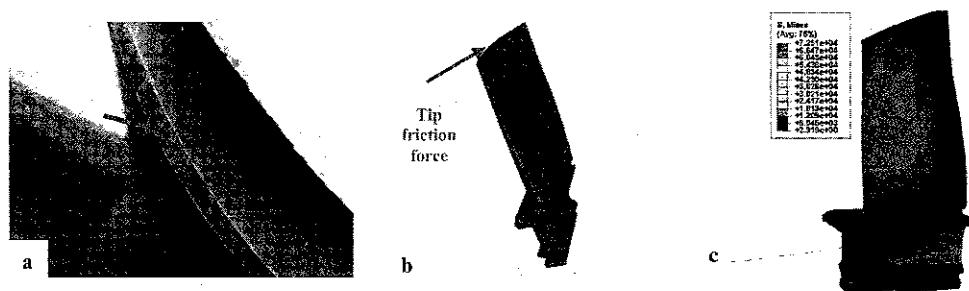
sources for the blade, (a) gas dynamic fluctuations and (b) blade tip rubbing. No significant evidence of gas dynamic pulsation abnormalities were found due to nozzle passing. As a consequence; normal gas dynamic fluctuations are most unlikely to be the excitation source. On the other hand; the rubbing between blades tip and vane upper shroud was evident from the vestige of wear at the tip of the blades which would occur in the form of an impulse load (Fig. 3a). It should be mentioned that in this turbine design; blades rotate under the vane upper-shroud roof functioning as shroud segment feature. This loading has been analyzed to determine whether it could contribute to the failure. Rubbing is essentially a “stick-slip” phenomenon [3]. In the case of a resonant or near resonant operation under these harmonic forces the blade can suffer a significant reduction in the design life. In a turbine stage, tip-rubbing can create a dynamic source of excitation that is most likely to vibrate blades at their second vibration mode. In among; the blade with fatigue marks was probably experienced most extensive rubbing and then has been fractured from the section with maximum vibratory stress near mean line section. The magnitude of stress was created by such a rubbing is impossible to predict precisely unless direct measurements of the tip displacement have been made. Therefore; in order to calculate the dynamic stress of second mode excitation, a harmonic analysis was performed in the condition of different harmonic force 100, 300, 500 and 700 N when applied as a tip rubbing force. Fig. 3c illustrates the stress distribution that resulted when rubbing was simulated.

Fig 3.a) tip rubbing vestige b)Representation of tip rubbing force c) Resonant stress in 2nd mode- 300 N rubbing force

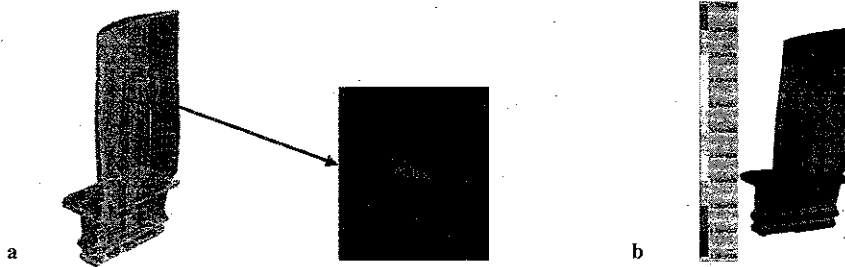
In this step by using of FRANC3D software, the fracture mechanic behavior of a crack on the airfoil of the blade is simulated to predict whether crack initiate and propagate under already mentioned operation condition. According to the theory of fracture mechanics, a certain level of vibratory energy is required to initiate a crack. The threshold stress intensity factor (ΔK_{th}) for IN738 material in gas turbine environment is approximately 8MPa \sqrt{m} [4]. The values lower than threshold stress intensity factor is not providing sufficient energy to initiate and propagate a crack. For a complicated geometry and stress field produced by a complex three-dimensional structure like the airfoil of the gas turbine blade, the computer model is used to explicitly represent the damage and directly compute the ΔK along the crack front. So a boundary element model of the blade was constructed by OSM/FRANC3D [5]. In this approach; the complex geometry of the blade including sophisticated geometry of internal cooling system has been considered. Centrifugal and gas pressure loads were applied to the model as the boundary condition of the problem. The dynamic stress induced by alternative tip friction force has been calculated by FEM harmonic analysis and introduced into FRANC3D software as a cyclic stress. A semi-elliptical edge crack which is oriented approximately normal to the surface is introduced into the airfoil (Fig. 4a). The dimension is 0.5 mm length by 0.25 mm depth. The size and location of the initial flaw are taken from the

Fig 4. a) Typical model of blade in OSM. b) Superposition of centrifuge, Gas bending and 300 N harmonic forces in FRANC3D

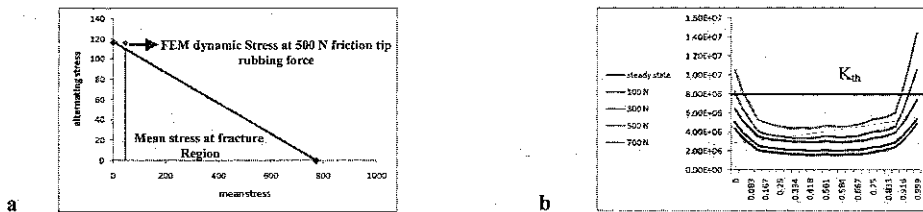
According to Fig. 5b the calculated stress intensity factors indicate that only with the tip rubbing force more than 500 N, initiation and propagation of a fatigue crack is susceptible. This is in agreement with the result of Goodman diagram and FEM harmonic analysis (Fig. 5a). According to Goodman diagram an alternating stress of 110MPa is needed to occurrence of fatigue at the airfoil. Harmonic stress simulation by commercial FEM software shows this alternating stress is allocated in nearby the fracture region when 500 N tip rubbing friction forces is applied.

Fig 5. a) Goodman diagram. b) K_I stress intensity factor for different condition
